Uniform Mitigation Verification Inspection Form

| Address: 8305 NW 61 Street - Bldg C | | Home Phone: (561) 914-7542 |

Elevation Photos

8305 NW 61 Street - Bldg C

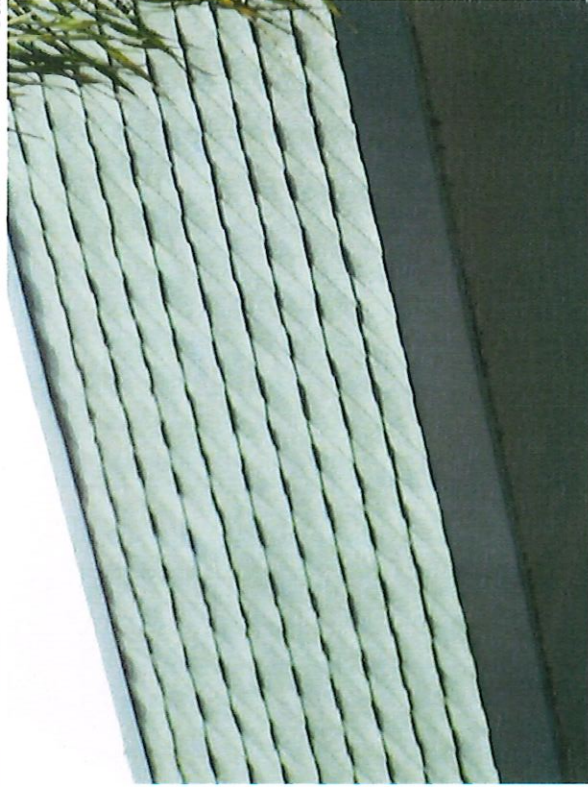
| 2.1 Roof Covering Type: | Permit Application Date | FBC or MDC Product Approval # | Year of Original Installation or Replacement | No Information Provided for Compliance |
|---|---|---|--|--|
| <input checked="" type="checkbox"/> 1. Asphalt/Fiberglass Shingle | 01 / 18 / 2019 | Prmt#: 190282 | _____ | <input type="checkbox"/> |

Architectural/Dimensional Shingle Roof Covering

Permit #: 1900000282 **Application Date: 01/18/2019**
Description: RE-ROOF SHINGLES
Permit Status: FINAL INSPECTION **Status Date:** 02/01/2019
COMPLETE
Type: ROOF **Contractor:** Not Available
SHINGLE/METALPAN
EL(ONLY)
Job Cost: \$40000.00

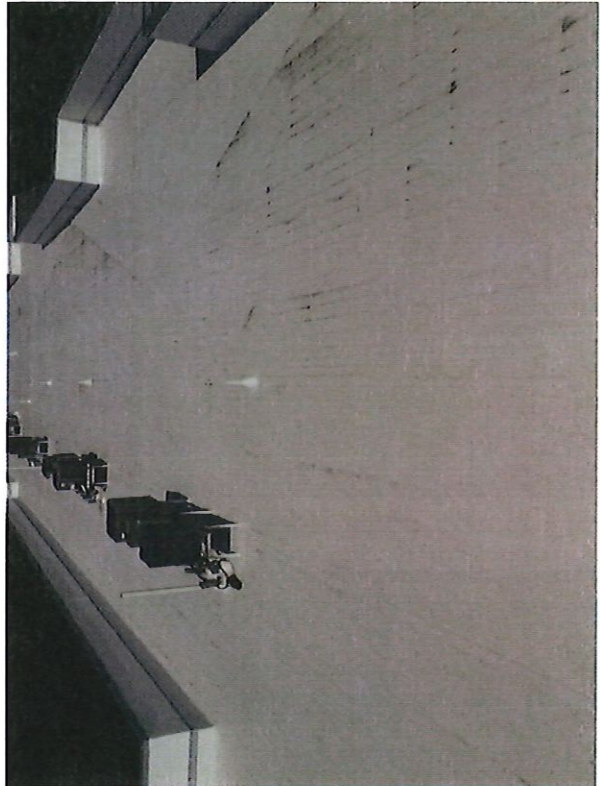
| 2.1 Roof Covering Type: | Permit Application Date | FBC or MDC Product Approval # | Year of Original Installation or Replacement | No Information Provided for Compliance |
|---|---|---|--|--|
| <input checked="" type="checkbox"/> 5. Membrane | 06 / 14 / 2024 | Prmt#: 242922 | _____ | <input type="checkbox"/> |

Membrane Roof Covering

Permit #: 2400002922 **Application Date: 06/14/2024**
Description: RE-ROOF FLAT TPO 17637 SF
Permit Status: FINAL INSPECTION **Status Date:** 12/10/2024
COMPLETE
Type: ROOF FLAT (ONLY) **Contractor:** Not Available
Job Cost: \$0.00

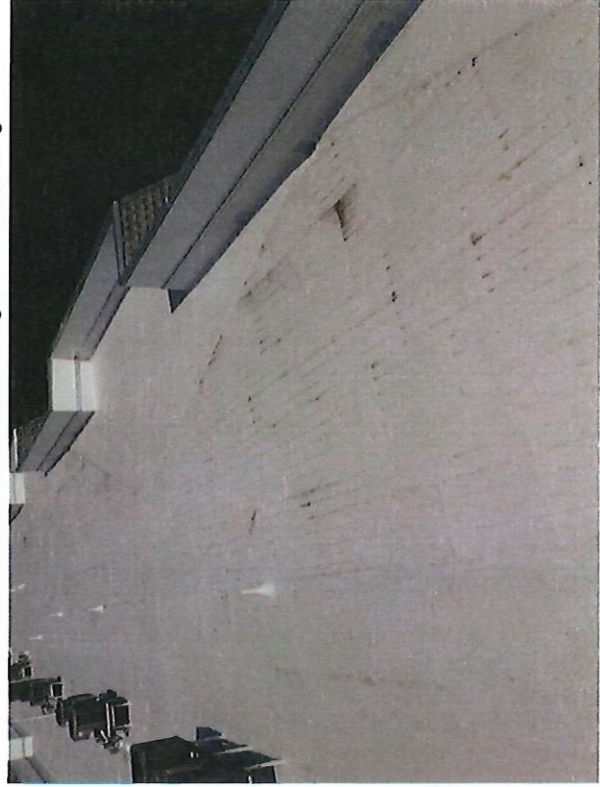
- D. Reinforced Concrete Roof Deck.
- E. Other: _____
- F. Unknown or unidentified.
- G. No attic access.

Reinforced Concrete Roof Deck

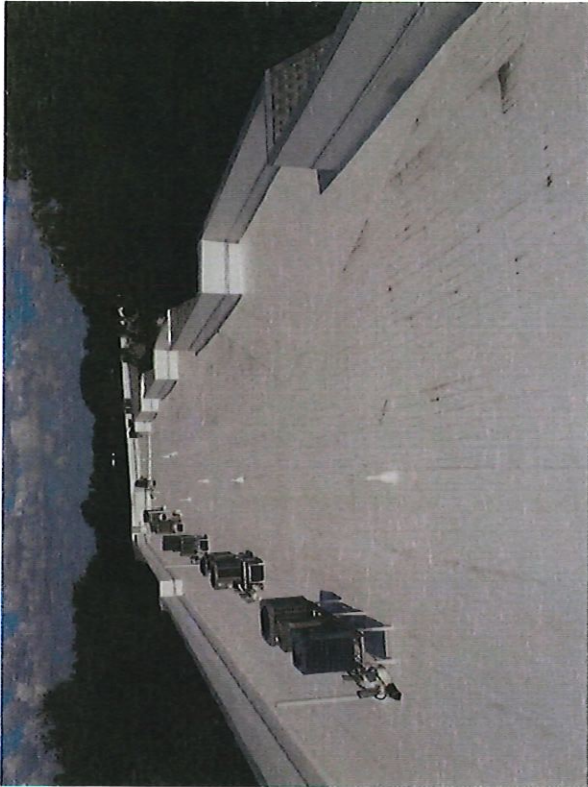
Structural: Reinforced Concrete

| Masonry/Concrete: | <u>100</u> % |

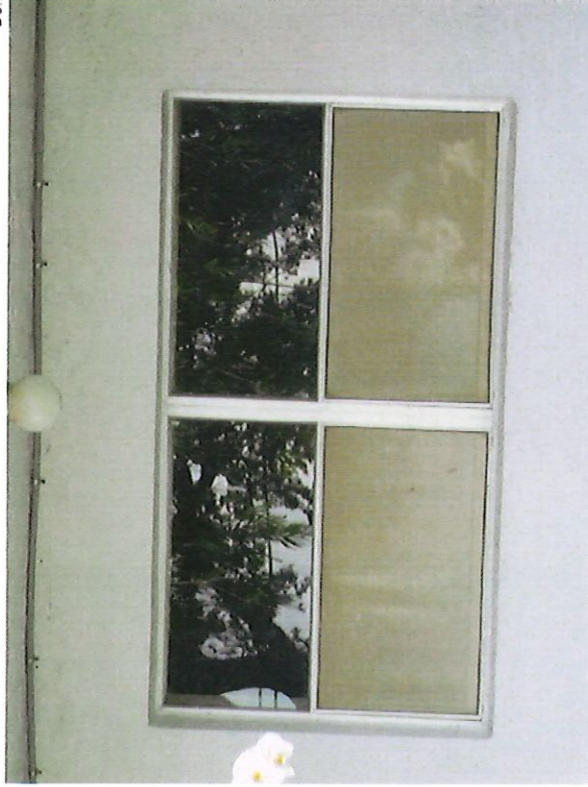
| Opening Protection Level Chart Place an "X" in each row to identify all forms of protection in use for each opening type. Check only one answer below (A thru X), based on the weakest form of protection (lowest row) for any of the Glazed openings and indicate the weakest form of protection (lowest row) for Non-Glazed openings. | | Glazed Openings | | | | Non-Glazed Openings | |
|--|---|---|---|---|---|---|---|
| X | No Windborne Debris Protection | X | | | | | |

Unprotected Window

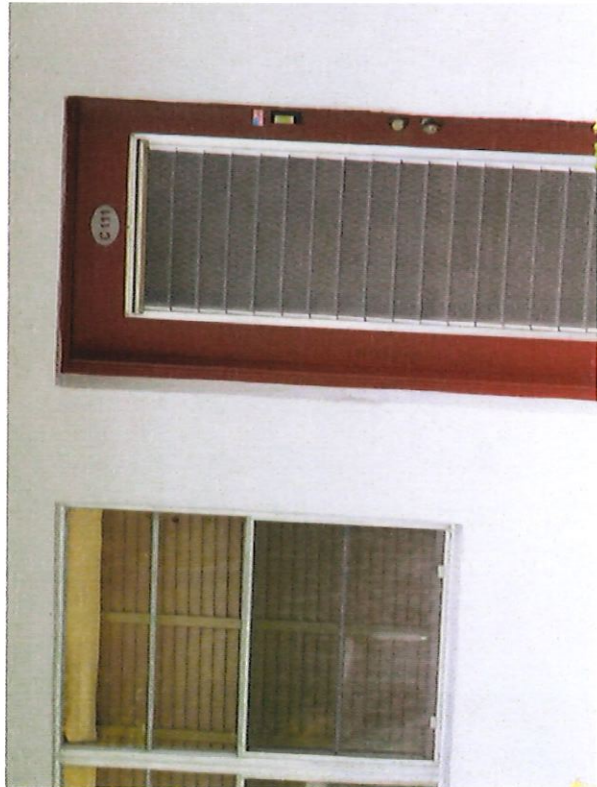
Unprotected Glazed Entry Door
